Conservation Area Appraisals  
in the Yorkshire Dales National Park

# Marske

Adopted 30<sup>th</sup> September 2025

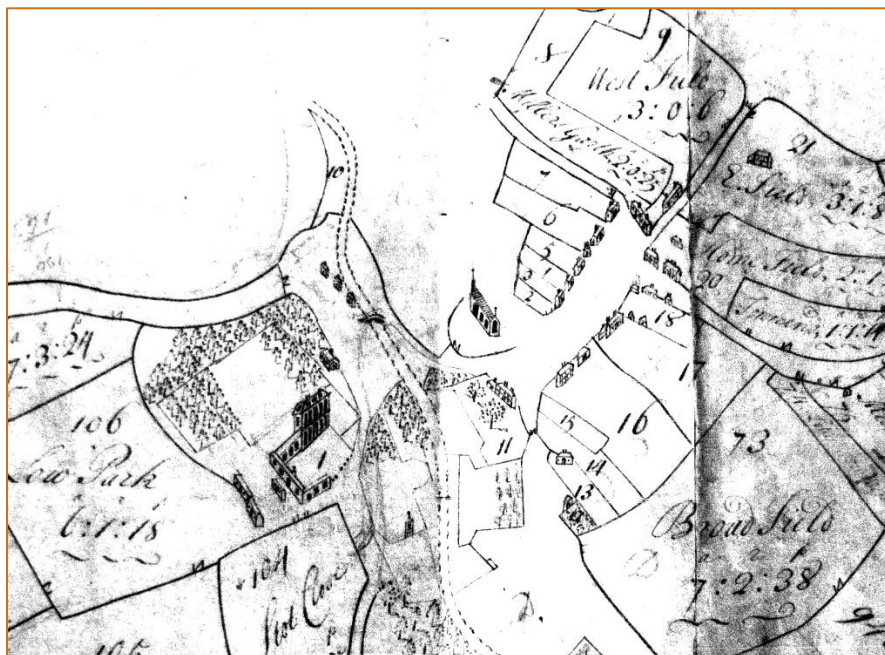
**Figure 04:** Estate plan of Marske Hall and village 1732 (North Yorkshire County Record Office reference ZAZ(M) 2 Hutton of Marske family archive)

The earliest available map evidence of Marske and Marske Hall dates to a 1732 estate plan which was drawn up for John Hutton II of Marske Hall, preceding an extensive programme of building works in the village. The 1732 plan depicts several elements of the village which are extant, with the Hall, church, Marske Beck and roads shown. It is also possible to discern several field names surrounding the village, as well as the deer park to the west of the hall. However, the plan shows a number of properties lining the north and south sides of the main thoroughfare (on the current alignment of part of the main road), which no longer exist.

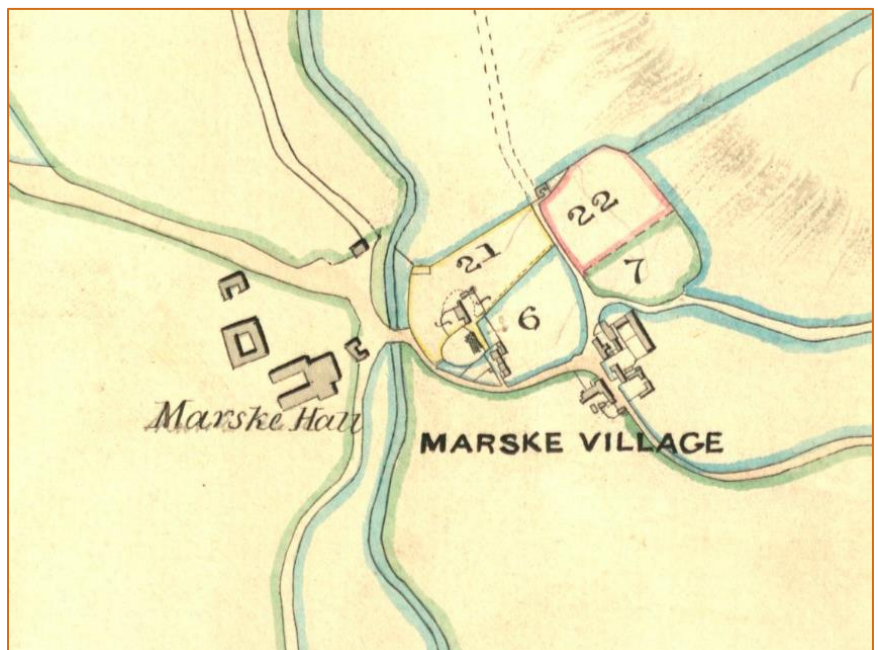
**Figure 07:** Extract from 1845 Tithe apportionment plan.

Next available mapping depicting the village is the 1845 Tithe apportionment plan (**Figure 07**). The road layout is consolidated by this time, with many of the key buildings in the village constructed, such as Home Farm, Manor House Farm and the former Dormouse Public House (later the Temperance Hotel and now the farmhouse for Temperance

Farm). Most of the land at this time is recorded as being owned by Timothy Hutton Esq. of Marske Hall, although some land parcels were glebe land, owned by the Reverend William Kendal, the Rector at St. Edmund's Church.

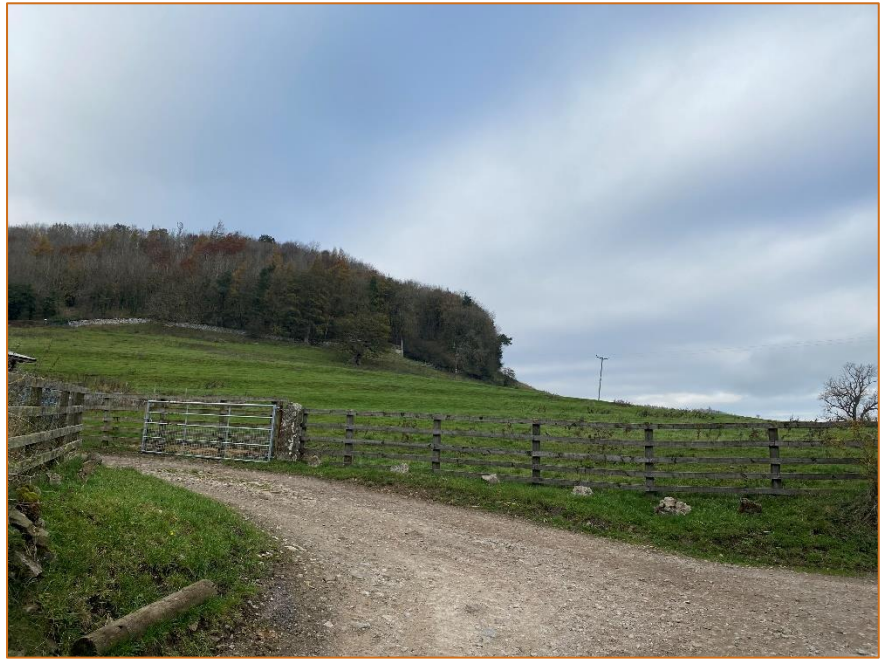
**Figure 16:** Lynchet strip earthworks at the foot of Marske Edge, just outside the conservation area's north-eastern boundary.

During the Medieval period, Marske was an agricultural community with an open field farming system, evidenced in surrounding ridge and furrow earthworks and surviving strip lynchets at the north-east approach to the village. A corn mill and two watermills are also recorded in Marske as existing around this time.

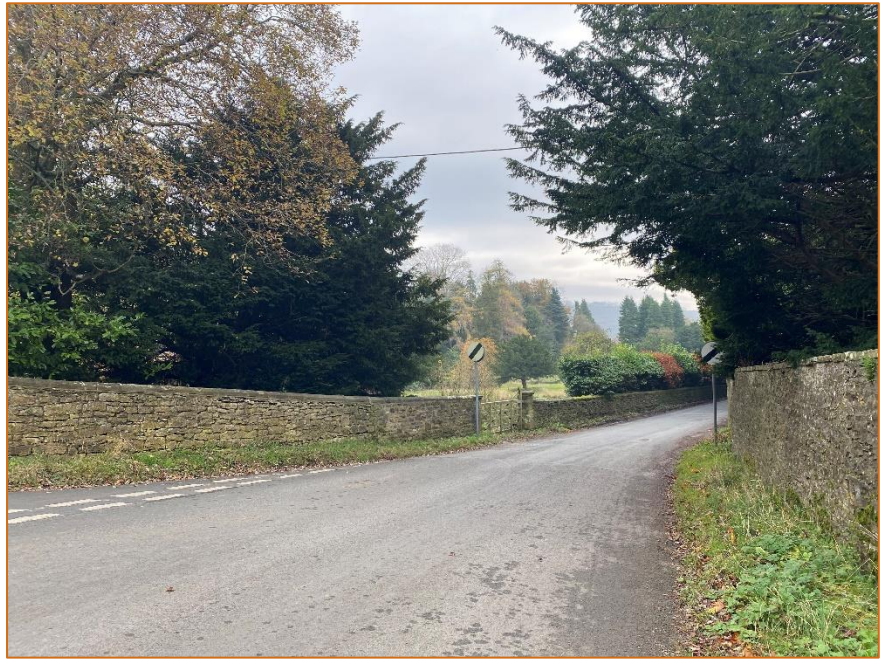
**Figure 21:** Example of stone walling along Cat Bank.

Spaces are predominantly enclosed by stone walls, both dry and wet laid, which are a common feature both in Marske and the wider Yorkshire Dales region. The wall of Marske Hall's former walled garden provides a strong boundary at the southern end of the main road.

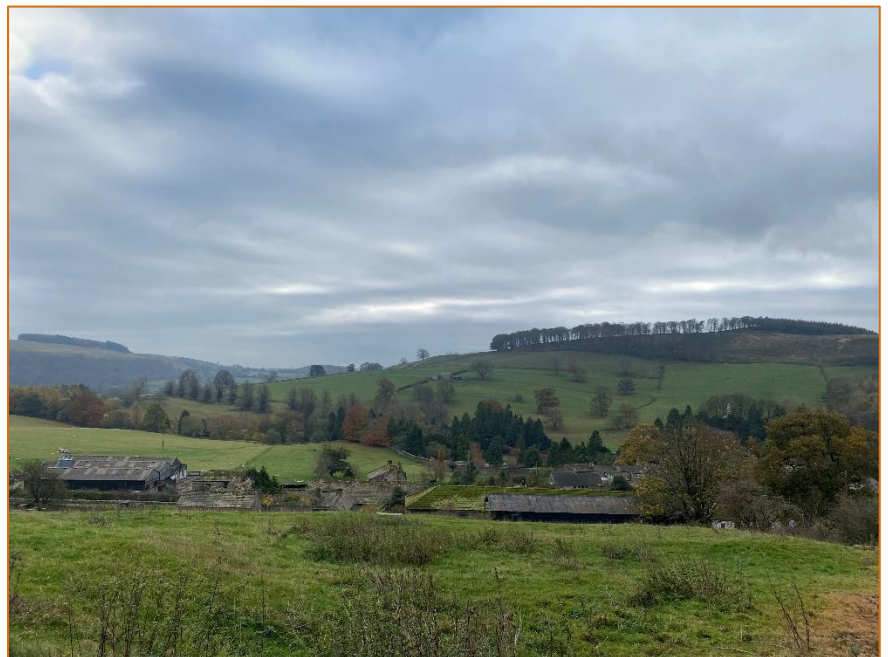
**Figure 28:** Key view 1, Applegarth Scar is located just out of frame to the left

**(1)** This view from the north, part way up Cordilleras Lane, takes in a panoramic view of the village from higher ground, with Applegarth Scar framing the landscape to the east and the rise of Cat Bank to the south, with the village nestled in the dale below. The grade II listed Gothic Barn is also visible on the opposing side of the dale from this view.

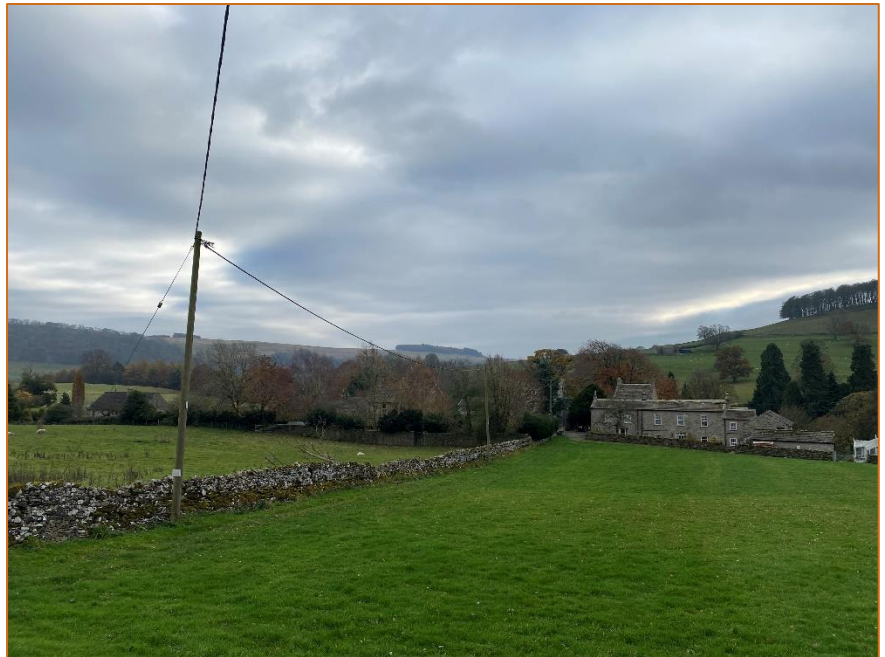
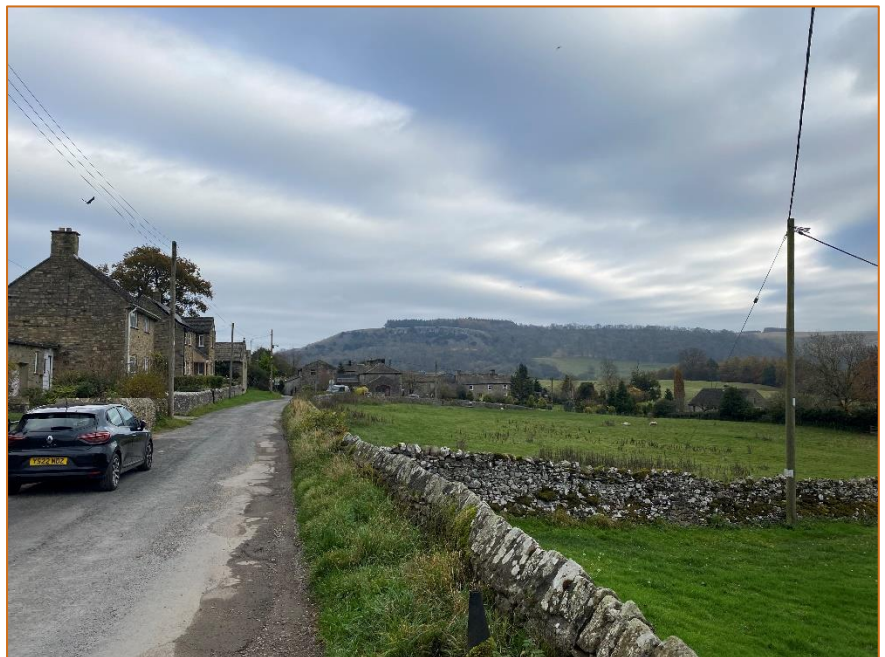
**(2)** This panoramic view from the western end of School Terrace takes in the paddocks to the rear of the Old Rectory and a glimpse view of the

church's bellcote, which is one of very few views of any part of the church outside of its immediate churchyard. It also includes an open view into the village centre, to the junction where the main road and Cordilleras Lane meet. The electricity pole features heavily in the foreground of this view and detracts from it.

**Figure 29:** View 2 looking south towards the rear elevation of the Old Rectory.

**Figure 30:** View 2 looking east over village paddocks towards the centre of the village.

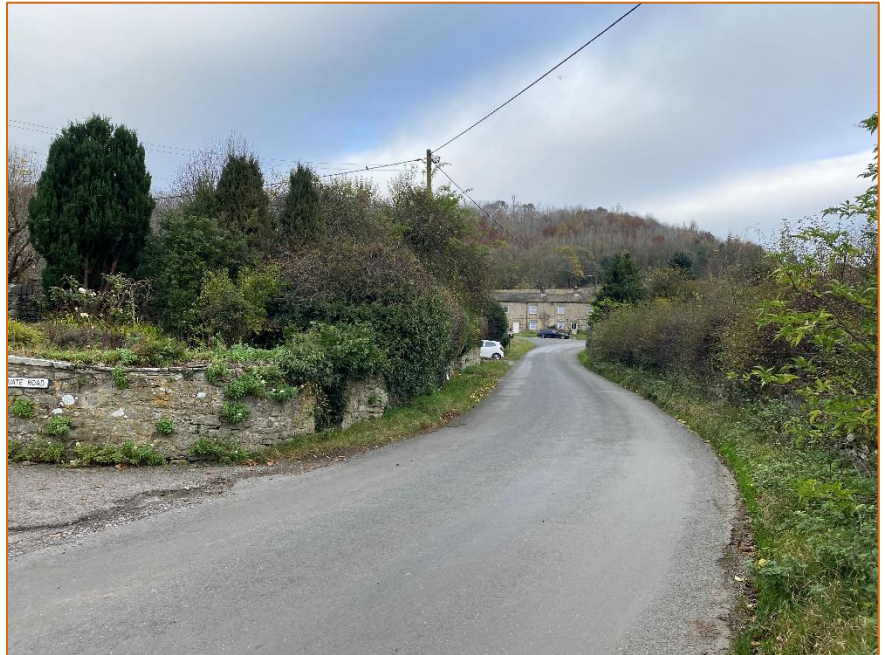
**Figure 31:** View 3 looking north along the main road, channelled by stone boundary walls and dense hedgerows

(3) This view looks north from the churchyard along the main road, and is terminated by the row of three cottages, which are positive contributors within the conservation area. The view is channelled by dense hedgerows and stone boundary walls.

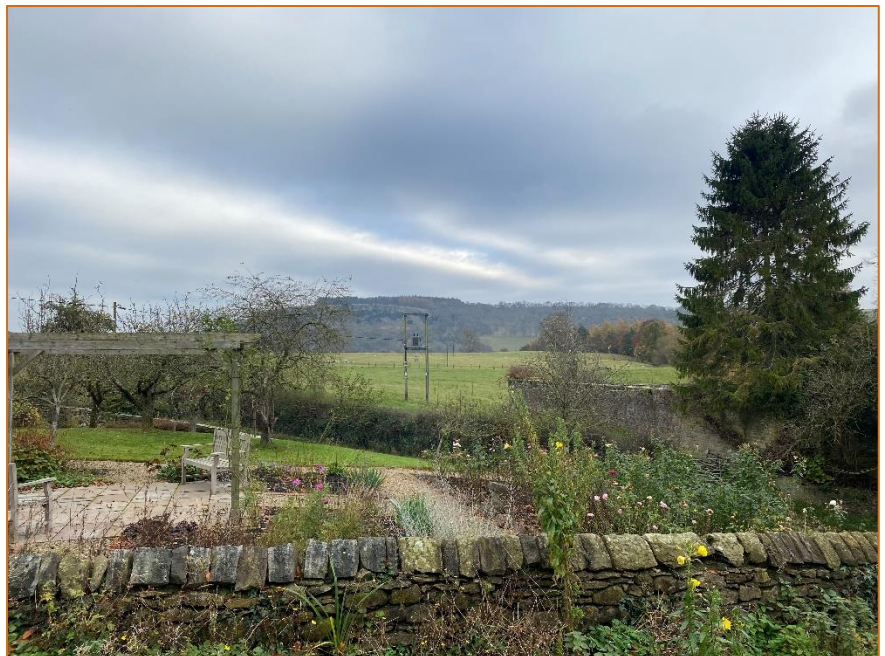
**Figure 32:** View 4 from the churchyard looking east towards Applegarth Scar

(4) View 4 looks from the churchyard to the eastern edge of the conservation area, across the garden and orchard associated with properties on Church Lane towards Applegarth Scar. It takes in the boundary wall of the former walled garden of Marske Hall and the belt of trees along Marske Beck. The otherwise clear view is disrupted by electricity poles and wires crossing the open fields.

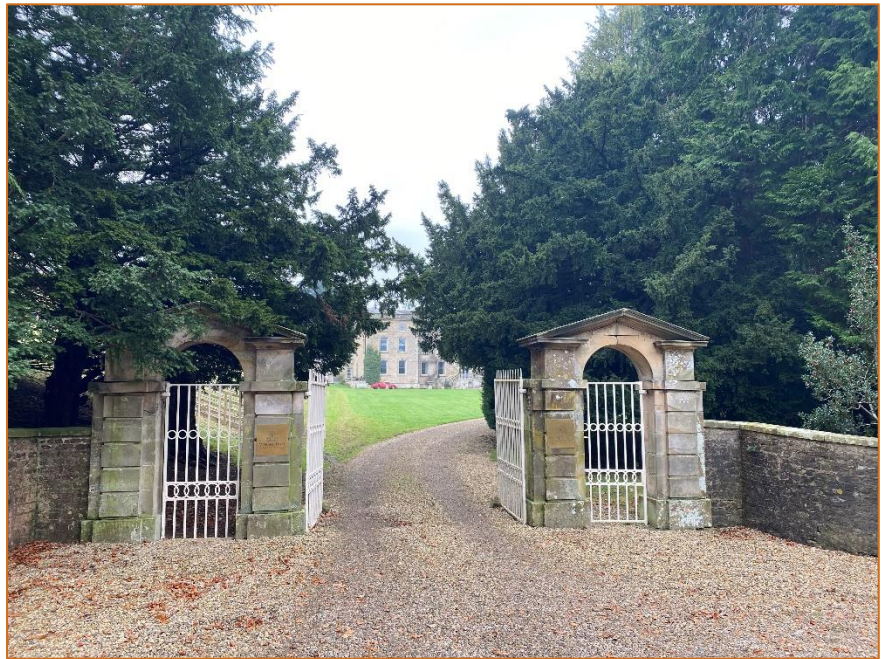
**Figure 35:** Entrance gates to Marske Hall, framing a glimpsed view of its lawns and principal elevation

(7) View 7 is an additional view of Marske Hall, this time a glimpsed view from its entrance gates on Cat Bank. The pedimented ashlar gateway frames the driveway and manicured lawns which lead to the hall's principal elevation.

- Ashlar sandstone gateway with wrought-iron gates, constructed circa 1836.
- Double gates to carriage drive, flanked by single pedestrian gates, all with square bars, with spear finials to carriage gates, all with interlocking circles in low mid rail and adjoining circles in high mid rail. Pedestrian gates within round-arched openings with banded rustication to pilasters with impostes and open pediments.
- Erected when the carriage drive through an arcade of lime trees was interrupted by a new road linking Marske with the Richmond-Reeth turnpike road, authorized in 1836.
- Group value with Marske Hall and estate.
- Current condition is good.

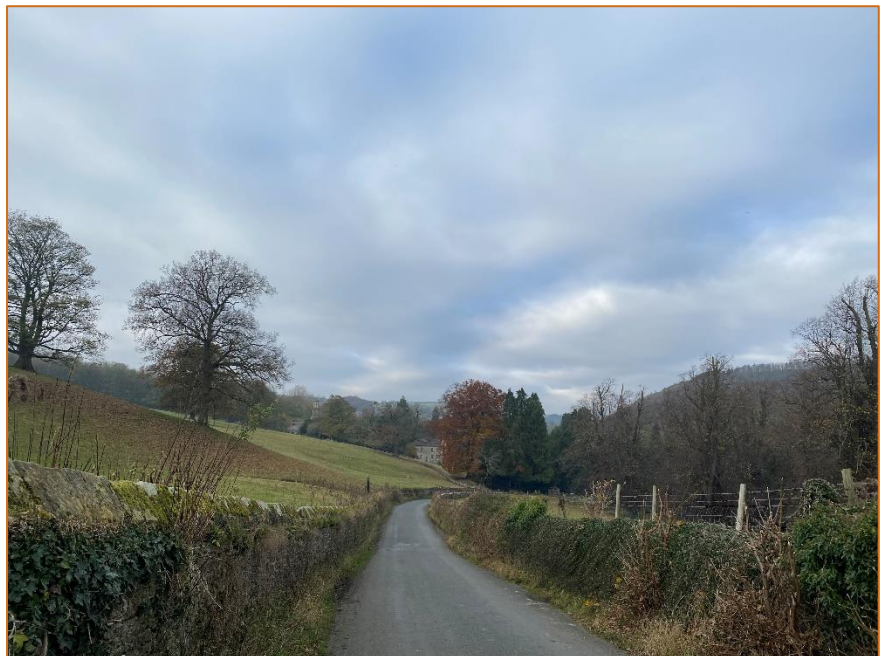
**Figure 36:** View 8 looking west along Cat Bank with long range views of Marske Hall and Stables

(8) View 8 takes in the meandering Cat Bank, bounded by stone walling, and looks west to include a long-range view of Marske Hall and Stables. The secluded nature of Marske can be appreciated from this view, as the village is almost invisible, nestled further into the valley behind mature tree cover, which provides a dense screen even in the winter months. It is also one of few views that is not impeded by electricity poles.

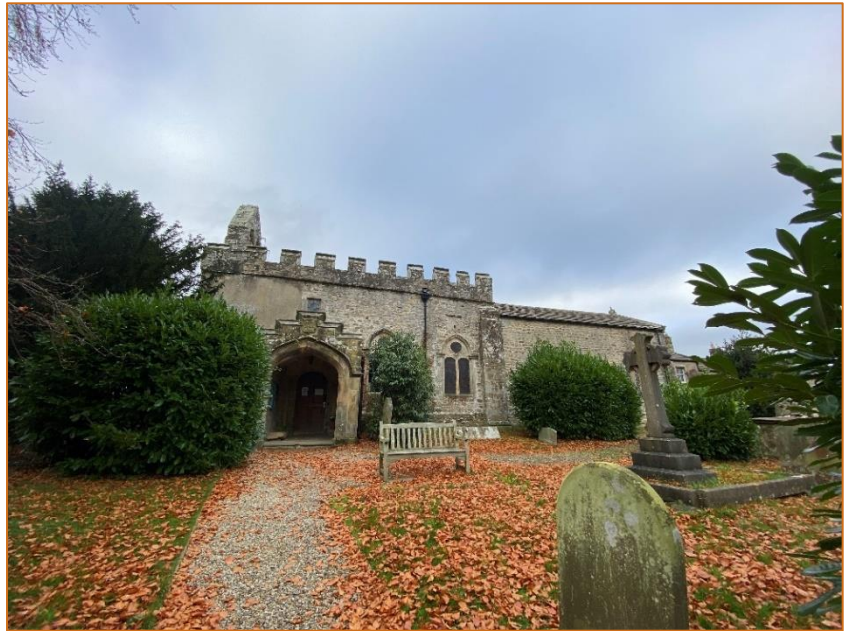
**Figure 39:** Church of St Edmund

- Parish church with 12<sup>th</sup> century origins and alterations/additions in 17<sup>th</sup> and early 19<sup>th</sup> centuries
- The 17<sup>th</sup> and 19<sup>th</sup> century works are attributed to the Hutton family.
- Sandstone rubble construction with render to north and west and flat tone slate roof. Stepped buttress; crenelated parapet; flat roof; ashlar coping to right with gable cross
- Nave of three bays with north aisle, west bellcote, south porch and two-bay chancel with north aisle.
- Norman doorway within porch, southern elevation has pair of 2-light windows of 1683, that have inscription "IOHN HUTTON SQVIR", and sundial above.
- Interior has arcading to nave and chancel and rare surviving early Victorian box pews.
- Current condition is good, although appears to be suffering from water ingress due to inappropriate render to parts of the exterior.

The Church of St Edmund has experienced ongoing issues related to water ingress and movement, and its physical fabric has suffered somewhat as a result. The rendered northern elevation facing onto Church Lane appears to be in a poor condition. However, it is noted that the local community are undertaking a project to address issues and repair the church building.

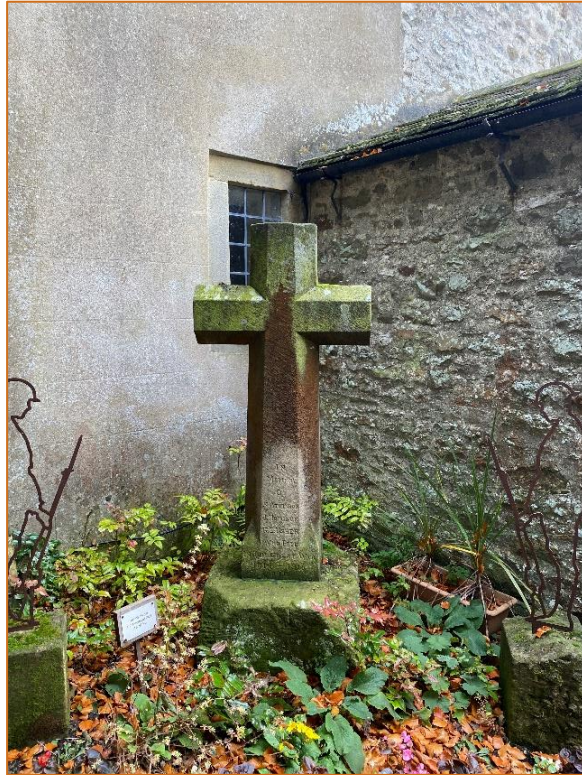
**Figure 40:** Cross base to the west of church porch

- Base of cross in ashlar sandstone. The listing description does not accurately illustrate the current location of the monument which is positioned to the west of the south porch.
- Likely 16<sup>th</sup> century date.
- Square in plan with broached corners. On top is a shaft and cross inscribed as a First World War Memorial which the listing description states is not of special interest.
- Group value with Church of St Edmund.
- Current condition is good.

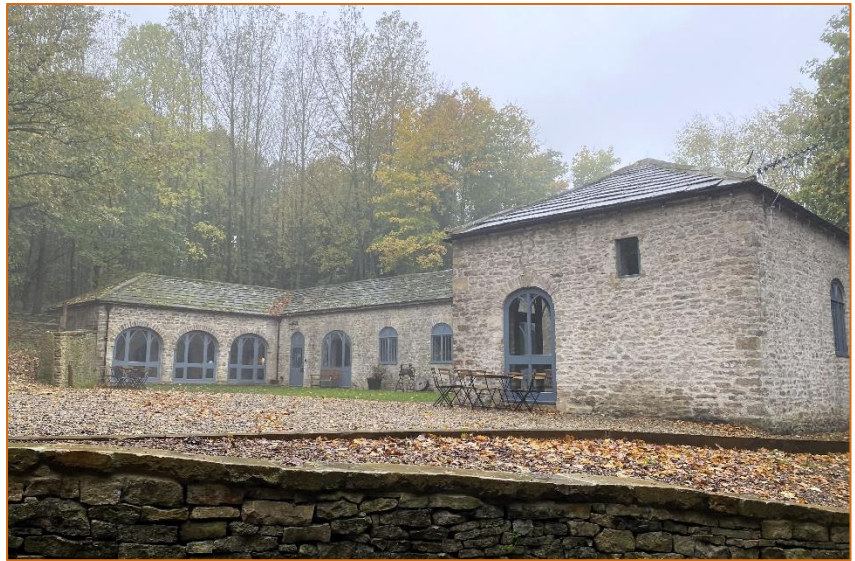
**Figure 41:** Farm buildings approximately 75 metres north-west of Marske Hall

- Farm buildings of an early-19<sup>th</sup> century date. Built for the Hutton family of nearby Marske Hall.
- Sandstone rubble construction with stone slate roofs. U-shaped plan and single storey. Main range has two wide doorways flanked by windows. Left and right wings project south-east, with arched openings.
- The building was listed for group value with Marske Stables.
- Current condition is very good. The building has recently been renovated (2023) for use as holiday cottages and has had new windows and glazed doors installed, with decorative tracery detail.

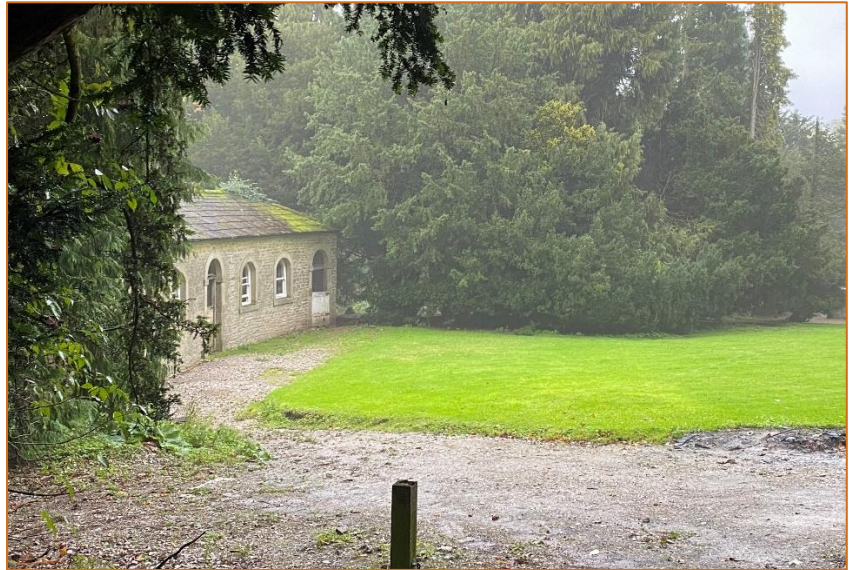
**Figure 43:** Kennels to rear of Marske Hall, viewed from the driveway of Stables

- Kennel building within grounds of Marske Hall, now disused.
- Constructed in the early 19<sup>th</sup> century for the Hutton family.
- Sandstone rubble construction with ashlar dressings and stone slate hipped roof.
- Single storey, built on a slight curve. bays have round-arched doorways, with 6-panel doors or sections of them, with ashlar surrounds with impostes and open ironwork fanlights. The windows are sashes in segmental-arched ashlar surrounds. Corniced ashlar stack between fifth and sixth openings.
- Group value with Marske Hall and estate.
- Condition is currently poor but planning permission and listed building consent applications for conversion to a dwellinghouse were lodged in 2023.

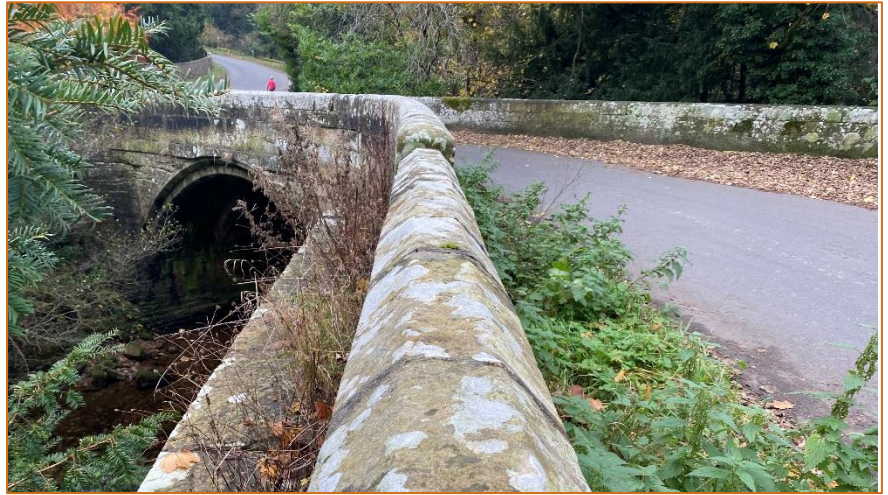
**Figure 44:** Marske Bridge

- Bridge of 15<sup>th</sup> century date, widened upstream in the mid to late 19<sup>th</sup> century.
- Single segmental arch in sandstone ashlar.
- Downstream elevation: chamfered arch with hoodmould, which cuts into band below later parapet, the ends of which are splayed on corbelled abutments so widening the plan area of the road. Upstream elevation: chamfered rusticated voussoirs to arch which is flanked by pilaster buttresses; deeply-projecting torus band below parapet which is of smooth ashlar. Both parapets have segmental coping.
- Current condition is fair.

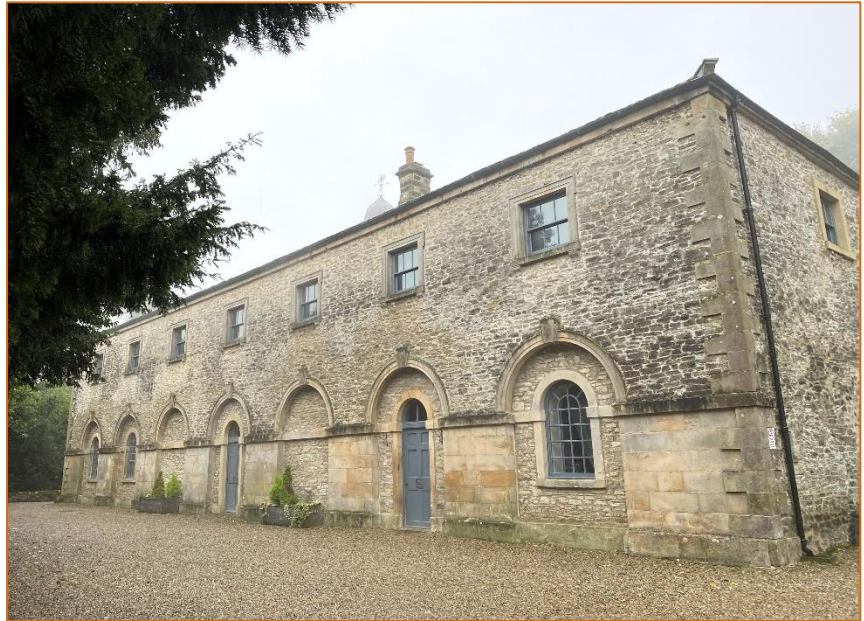
**Figure 47:** Marske Stables

- Former stables for race horses and carriage horses, with coach-house, constructed 1741.
- Designed by Thomas Worsley, of Hovingham Hall, for John Hutton, of Marske Hall.

- Quadrangular plan of two storeys. Principal elevation is 3:1:3 bays and central bay projects slightly.
- Coursed sandstone rubble, ashlar plinth, and walling up to impost level. Ashlar projecting quoins at ends and to central bay.

- Ground floor has round-arched openings, that in central bay open and with Gibbs surround, the others each with ashlar architrave with tripartite keystone, and continuous impost band, and with recessed ashlar panel. First floor has eared ashlar architraves with sill brackets. Cornice band, moulded in centre bay. Roof hipped at ends and also over central bay, which supports chamfered rusticated ashlar clock tower with cornice, surmounted by 19<sup>th</sup> century cupola with lead roof and weather-vane. Entrances to stables and cobbled courtyard from inside central archway.

- Group value with Marske Hall and estate.
- The stables building has recently undergone extensive renovations (2023) to create a series of holiday apartments and cottages. Building is currently in very good condition as a result.

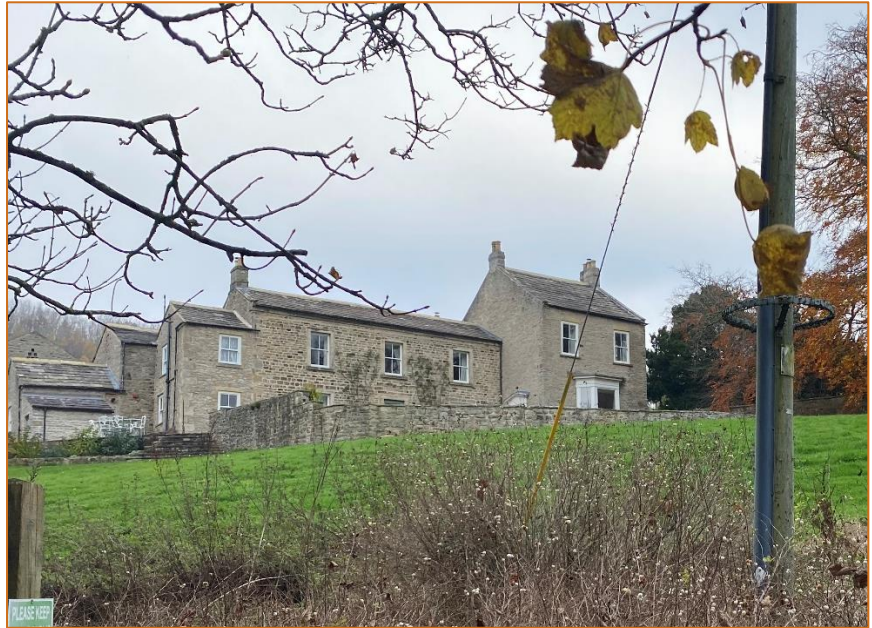
**Figure 48:** The Old Rectory

- Former parsonage, now a private residence. Constructed in 1753 for John Hutton of Marske, with later additions.
- Coursed rubble sandstone over two storeys with stone slate roofs.

- Main house to centre has quoins to left. Plain ashlar surrounds to windows and door. Eaves band. Shaped kneeler and ashlar coping to left. End stack to left. Lower bay to left, with quoins to left and a 4-pane sash window on each floor. To the right is an early 19<sup>th</sup> century addition, projecting forward, with quoins to left, canted bay window on ground floor, 4-pane sashes above; ashlar coping, brick end stacks.

- Condition of the building is good, and has recently undergone sensitive roof repairs.

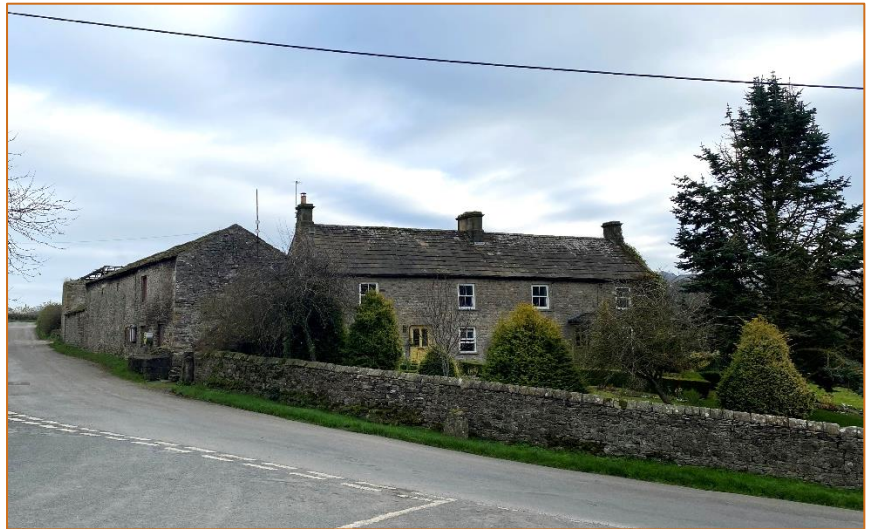
**Figure 50:** Home Farm

**Home Farm.** An 18<sup>th</sup> century farmstead with likely earlier origins. Main farmhouse of a vernacular style has six irregular bays and two storeys, coursed rubble construction, stone slate gabled roof and three chimney stacks. Windows have plain stone sills and flat lintels with traditional style windows. Although no longer part of a working farm, the building holds historical and aesthetic value, as well as communal value as a prominent building in the village for centuries.

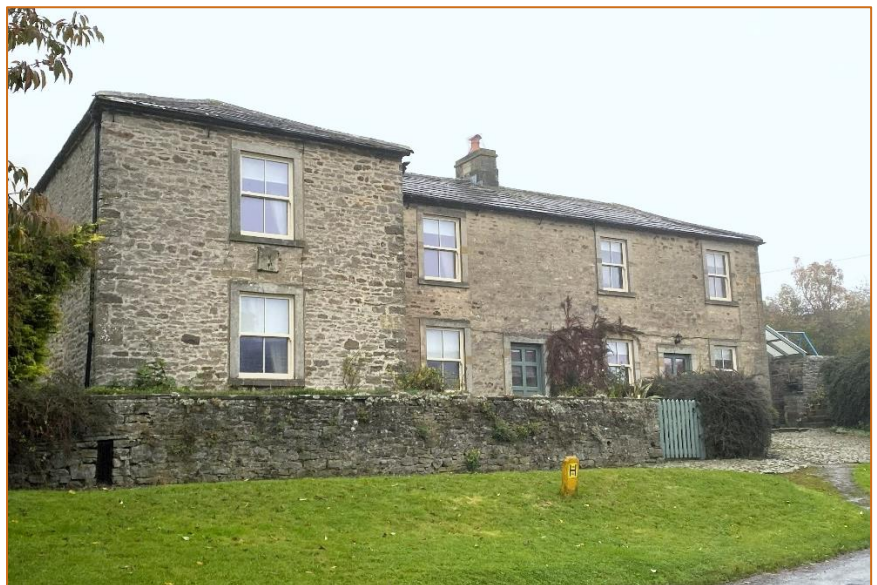
**Figure 51:** Manor House Farm

**Manor House Farm.** An 18<sup>th</sup> century improved farmhouse in a more polite architectural style. Coursed rubble construction of two storeys and four bays, with projecting westernmost wing. Quoin detail and stone slate hipped roof. Ashlar window and door surrounds features diagonal carved pattern. Traditional style modern windows and doors. The building has historical value through its attribution to Hutton family of Marske Hall identified by a signature wall mounted sundial, although initials are very worn. The property also holds aesthetic value as a classically influenced 18<sup>th</sup> century farmhouse.

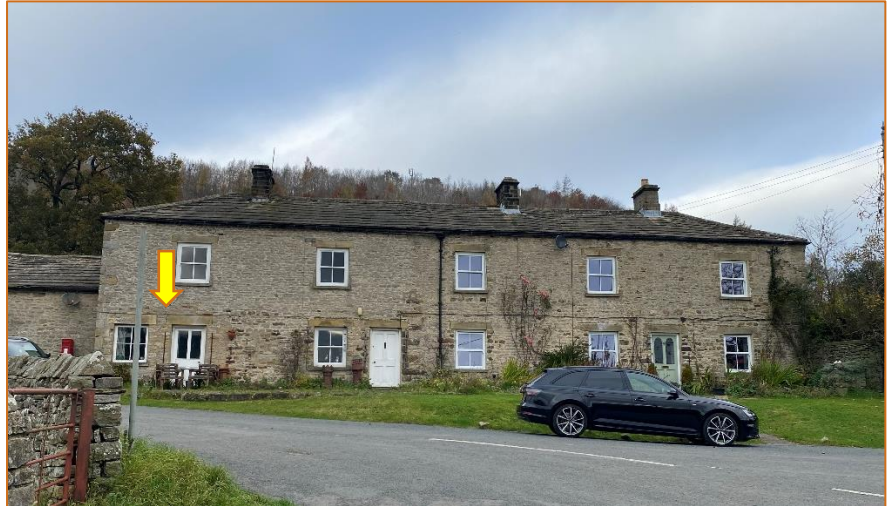
**Temperance Farm and Old Post Office Cottage.** 18<sup>th</sup> century row of cottages (west) and farmhouse (east, formerly the Dormouse Pub and later the Temperance Hotel). Coursed rubble construction with quoin detail, plain ashlar sills and flat lintels to windows and doors. Stone slate hipped roof. Traditional style, but modern windows and doors. The row holds strong historical value through its changing uses. Old Post Office Cottage (shown with yellow arrow below) has scarring to its frontage where a former shopfront was removed and infilled. Temperance Farm comprises the eastern section of the row.

**Figure 52:** Temperance Farm and Old Post Office Cottage. Scarring of former shopfront highlighted by arrow

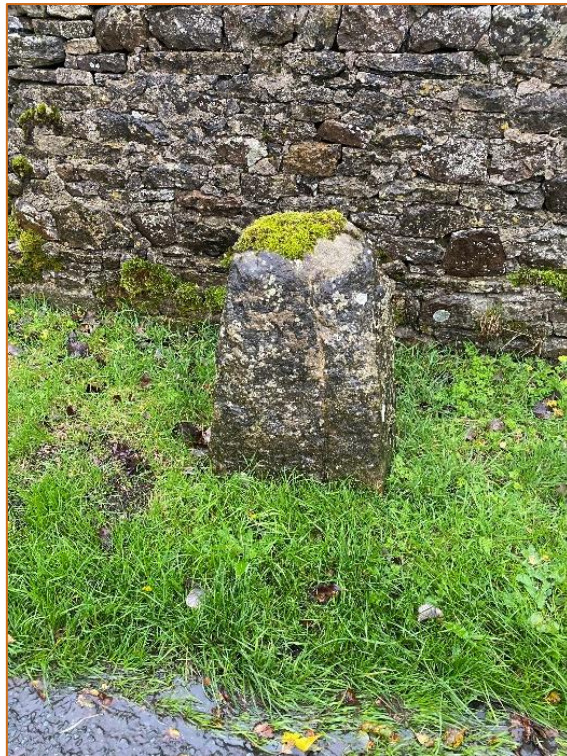
**Figure 53:** Cart stop stone

**Cart stop stones outside Home Farm.** Two projecting stone blocks outside the boundary wall of Home Farm, similar in shape and size to a milestone. Supposedly used as supports for carts to allow packhorses to rest.

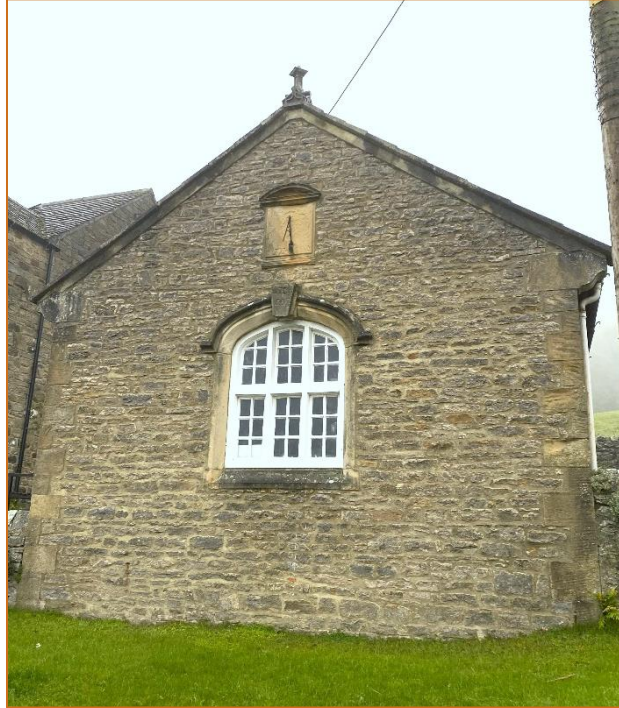
**Figure 54:** Old Smithy

**Old Smithy, School Lane/Cordilleras Lane.** An early 20<sup>th</sup> century former smithy, possibly rebuilt on the site of an earlier smithy.

Single storey, coursed rubble construction with ashlar quoins and carved kneelers beneath stone slate gabled roof. The small building has aesthetic value in its architectural detailing, which includes gable finials and a decorative hoodmould with keystone. The keystone reads JTDH 1907, referring to John Timothy D'Arcy Hutton II, and above is another sundial which may have been repurposed from an earlier building.

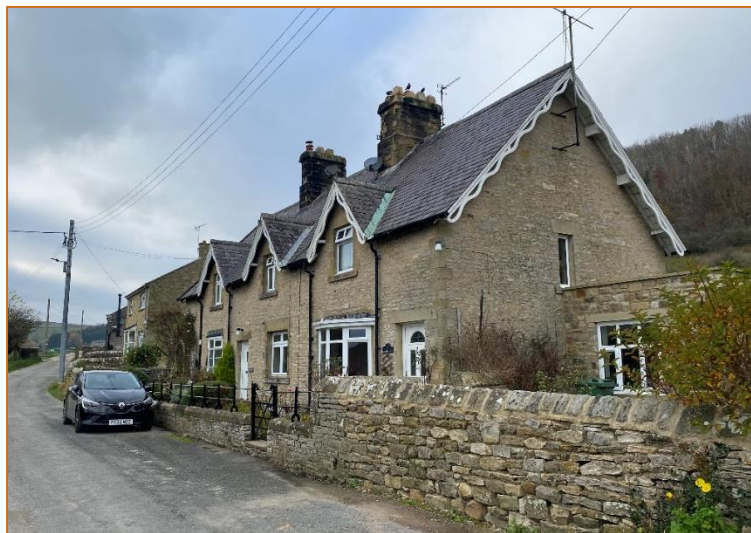
**Figure 55:** School Terrace

**School Terrace.** A row of three late 19<sup>th</sup> century cottages in an Arts and Crafts style. Coursed rubble construction with ashlar quoins and windows surrounds. Decorative white painted barge boards beneath a slate gabled roof. Modern uPVC windows and doors. The cottages have undergone some modern alterations, including window and door replacement, small extensions but still retain a pleasant aesthetic.

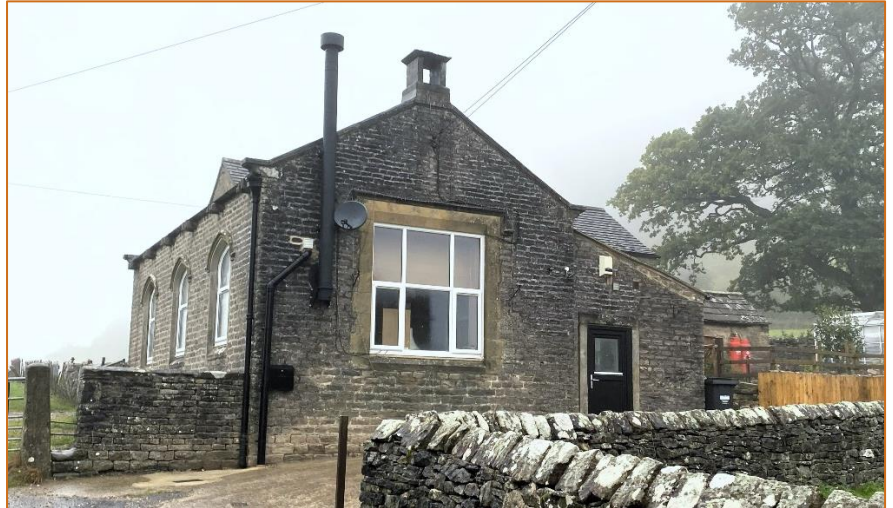
**Figure 56:** The Old School

**The Old School.** Constructed in 1841 by the Hutton family as the village school. Single storey, coursed rubble construction, large ashlar window opening to gable end with carved hoodmould. Three four-centred arched windows to southern elevation with carved hoodmoulds. Now empty bellcote to eastern gable end. The building holds strong historical and communal value through its purpose as the village school, which was still in used within living memory, only closing in 1961. The old school house has recently undergone a scheme of renovation for residential use, which has included the introduction of a tall stove flue and uPVC windows.

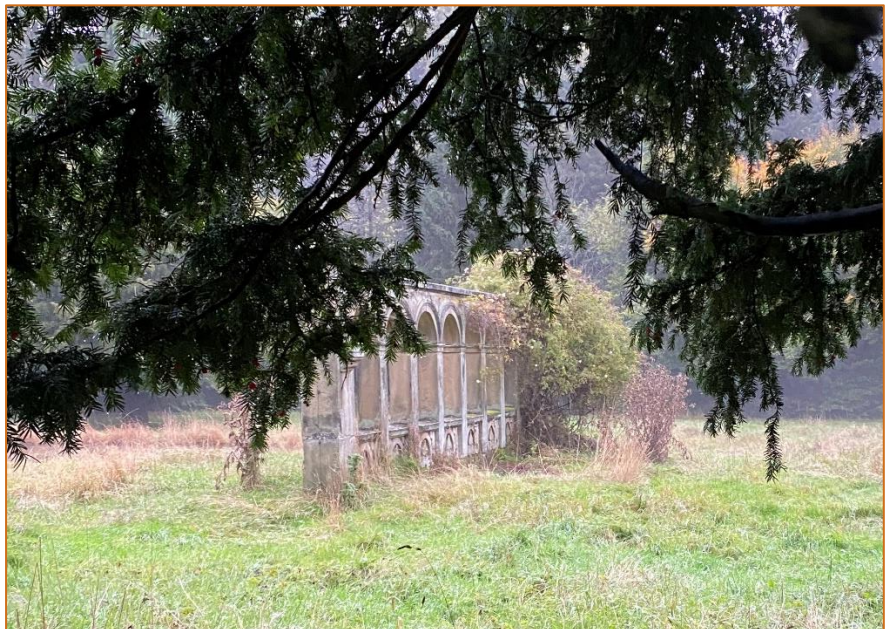
**Figure 57:** Folly in the garden of Marske Hall

**Folly in garden of Marske Hall.** An 19<sup>th</sup> century arcaded folly set within the garden area of Marske Hall. While not accessible by the public, the structure holds historical and architectural value in its illustration of the development of Marske Hall and landscape garden fashions of the 19<sup>th</sup> century.

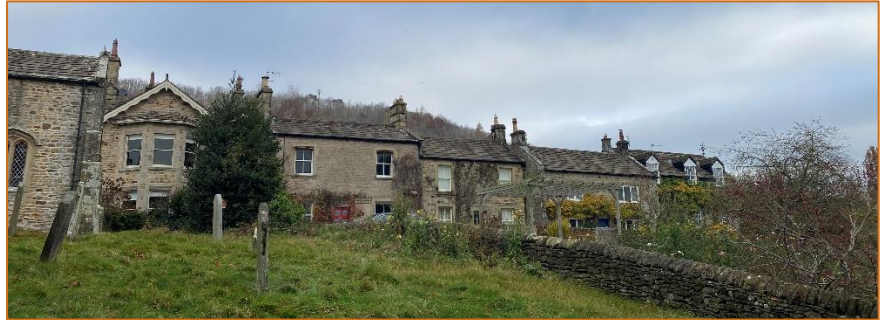
**Figure 58:** Properties along Church Lane, viewed from the churchyard

**Properties along Church Lane, including Yew Tree Cottage and Marske Lodge.** A group of fine cottages and houses dating from the late 18<sup>th</sup> century to the early 20<sup>th</sup> century. Set over two storeys with a mixture of coursed rubble and ashlar construction and all with stone slate roofs. Yew Tree Cottage and Marske Lodge bookend the row. Yew Tree Cottage has particular aesthetic value in its gabled dormers, which are an unusual feature within the village. Marske Lodge has aesthetic value in its more polite architectural style, signalling a higher status building, and decorative timber barge boards.

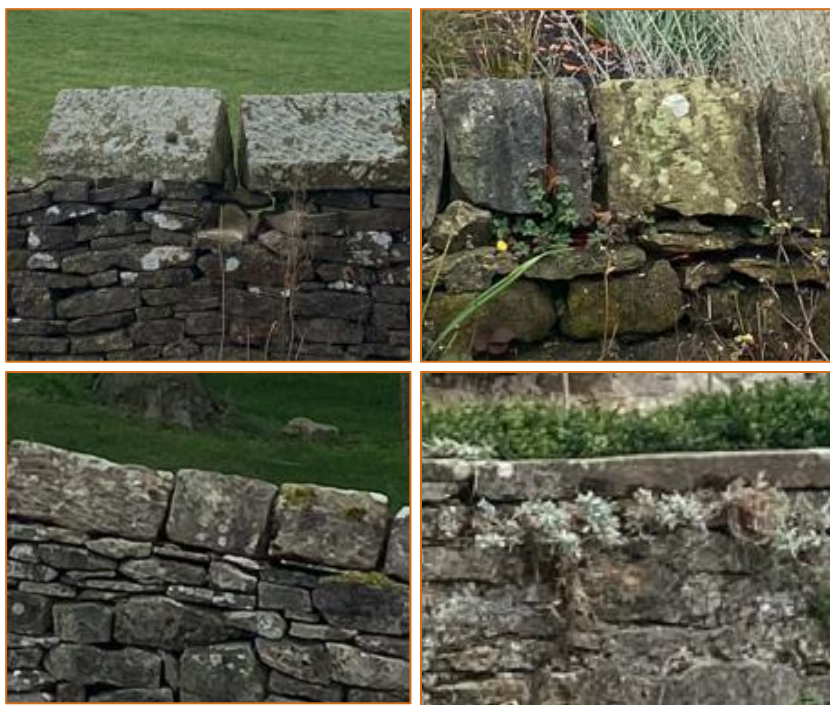
**Figure 60:** Different styles of coping stones

- Different styles of drystone walling, incorporating a variety of coping stone, such as large triangular ones (**Figure 61**)
- 18<sup>th</sup> and 19<sup>th</sup> century plain ashlar window sills and lintels.
- Quoin detailing to corners of properties (**Figure 62**)
- Stone wall boundaries around private gardens, wrought iron or timber gates
- External stone stair at Home Farm (**Figure 63**)
- Sandstone gravestones within the churchyard (**Figure 63**)

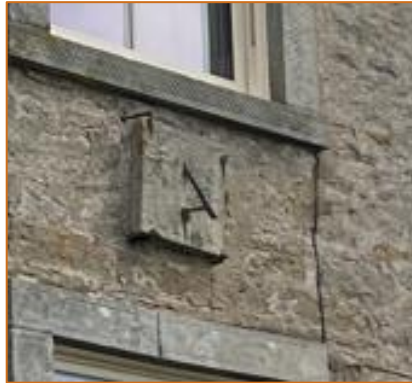
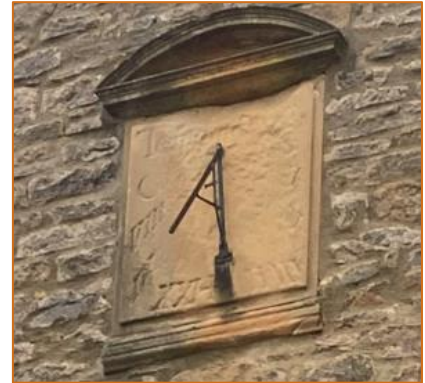
**Figure 63:** Examples of wall-mounted sundials

- 18<sup>th</sup> century sundial and initial stones set on a number of properties constructed by the Hutton family (**Figure 64**).
- Two cart rest stones
- Clock Tower at Marske Stables
- Carved kneeler stones to gable ends (**Figure 65**)
- Weathervane (Yew Tree Cottage)
- Memorial alcove and bench in commemoration of Mr George Shaw, owner of Marske Hall 1951-1966

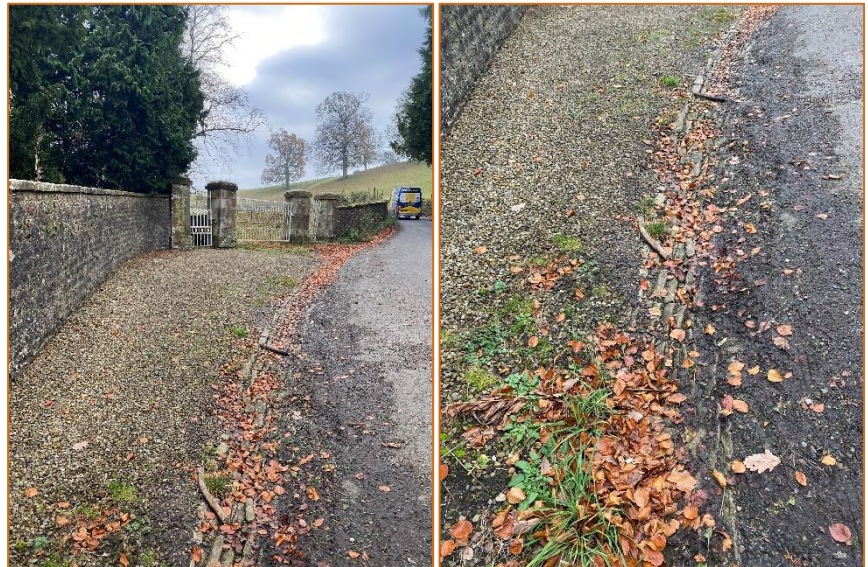
**Figure 66:** Surviving cobbled gutter along Cat Bank, outside the gates of Marske Hall

- Some surviving cobbled gutter along Cat Bank, outside the gates to Marske Hall (**Figure 67**)
- Surviving cobbled surfaces to the front of Manor House Farm and Temperance Farm farmhouses (**Figure 68**)
- Historic road sign with direction to Richmond
- Marske Bridge, with built in stone step-through stile and steps descending to riverside woodland footpath (**Figure 69**)

Stone cobbles would historically have been a prominent surfacing material, particularly to courtyards and forecourts to the front of buildings. Unfortunately, they are a dwindling sight in the Yorkshire Dales, so those surviving in Marske make a special contribution the character of conservation area.

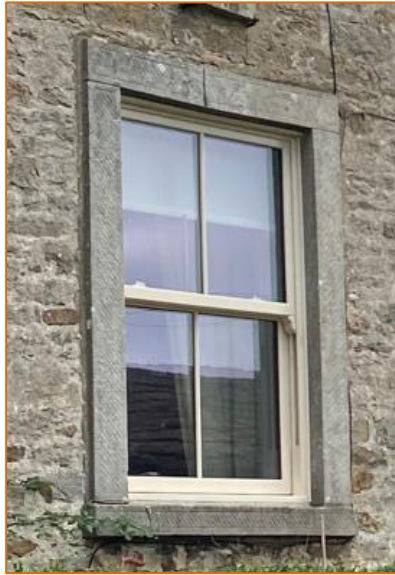
**Figure 76:** Example of high-quality timber window.

- uPVC windows in traditional buildings. At the time of research and survey for this appraisal, it was noted that there are a number of white uPVC windows in traditional buildings that detract from their aesthetic value and the overall character of the conservation area. There are, however, some examples of high-quality modern replacement windows (**Figure 77**). Owners of traditional buildings should be encouraged to use appropriate heritage-style timber window units wherever possible, and particularly on those facing the road.

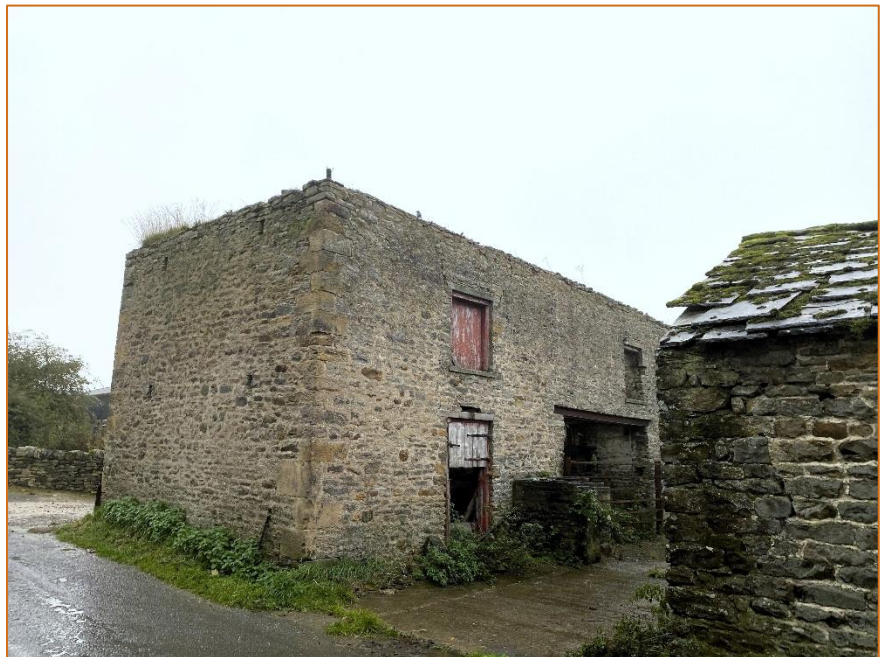
**Figure 77:** Agricultural building in disrepair at Manor House Farm

- Vacant agricultural buildings in disrepair. As discussed previously, buildings within the conservation area are generally in good condition. However, at the entrance to the village from the main road, there are a handful of agricultural buildings in a poor state of repair at Manor House Farm that stand out (**Figure 78**). Whilst they are working buildings, they carry a sense of neglect, and repair of the buildings should be encouraged.
